**PROJECT NAME: Construction Work for Wayne Johnson Community Center**

**BID NO: B191006**

**RE: ADDENDUM #1**

**MOLD REMEDIATION PROTOCOL  
WAYNE JOHNSON COMMUNITY  
CARBIDE PARK  
4102 MAIN STREET (FM 519)  
LAMARQUE, TEXAS**

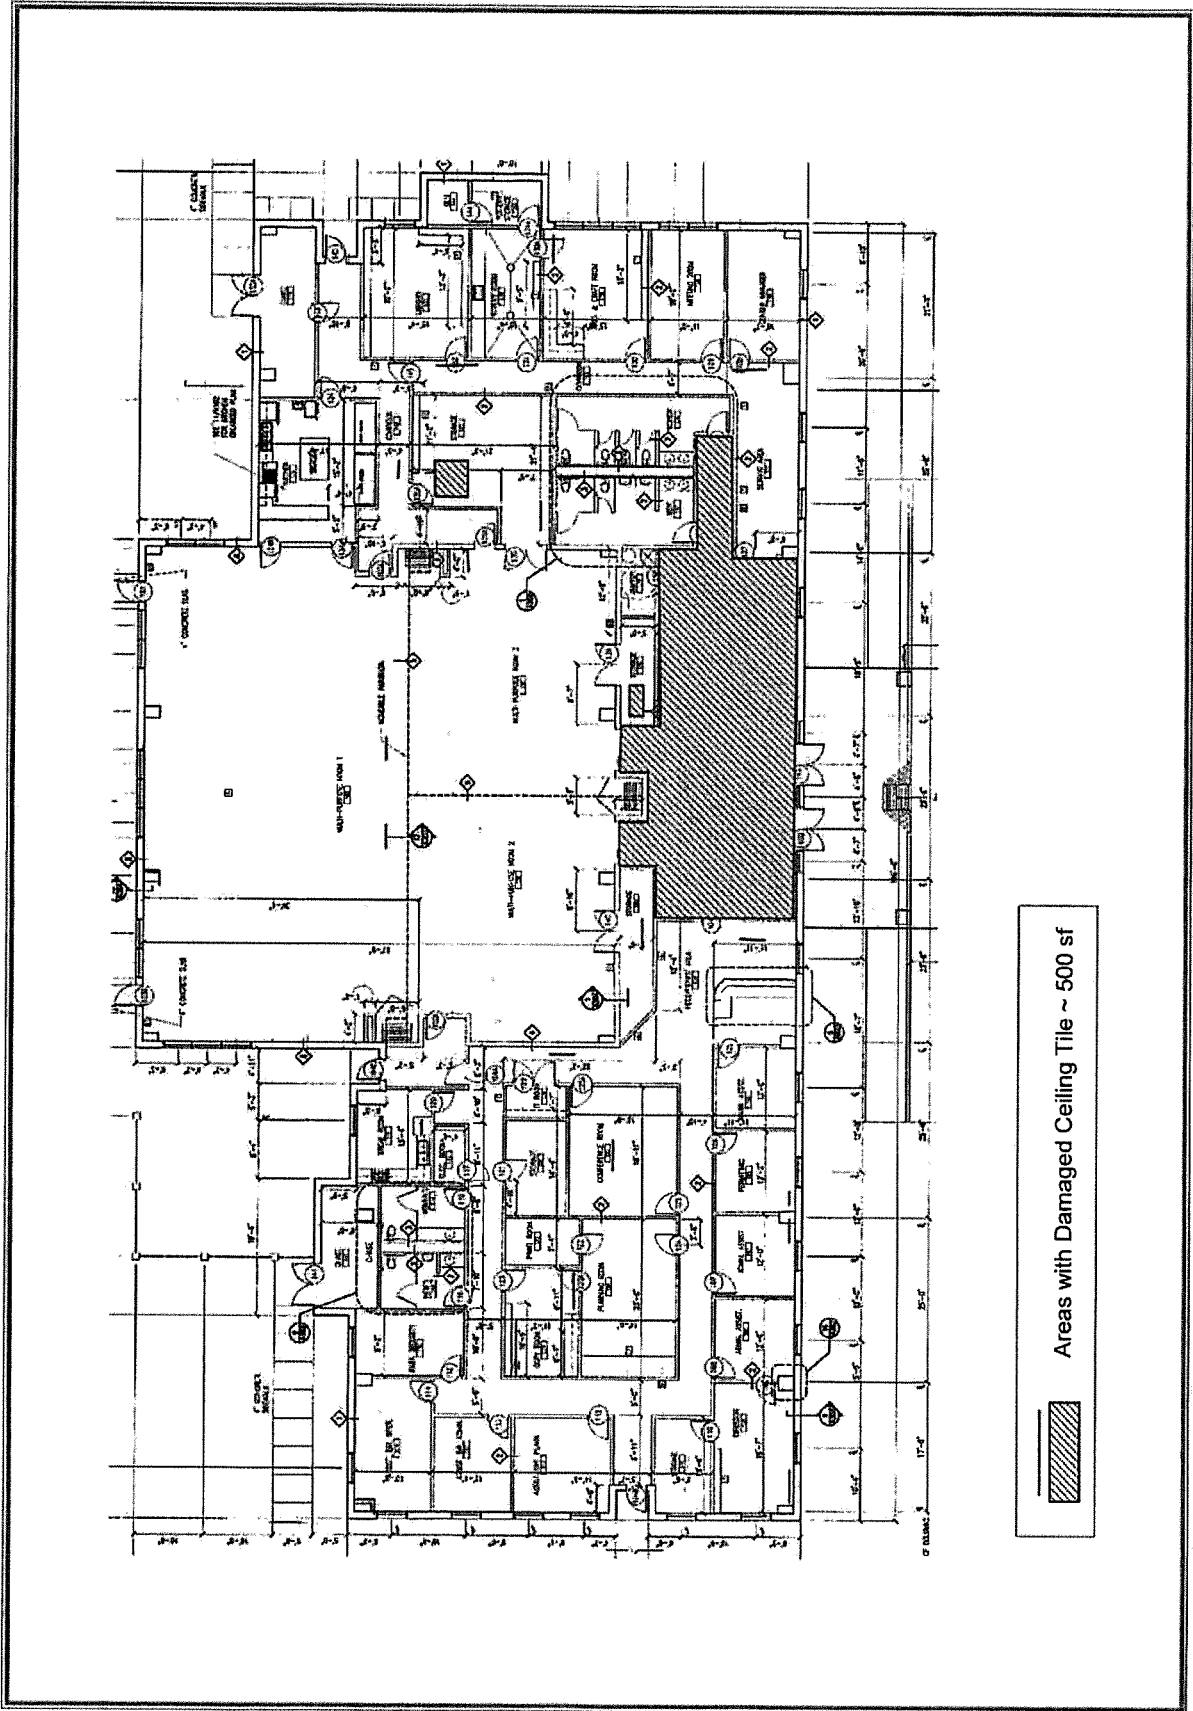
Areas with Damaged Ceiling Tile ~ 500 sf

- Ceiling tiles that are stained or have water and/or mold damage in the facility shall be removed, bagged and disposed of. Utilize methods to prevent damage to building components (e.g. ductwork, supply and return air grilles, plumbing, wiring/cabling, building alarm or fire equipment, etc.) during the removal of the ceiling tiles.

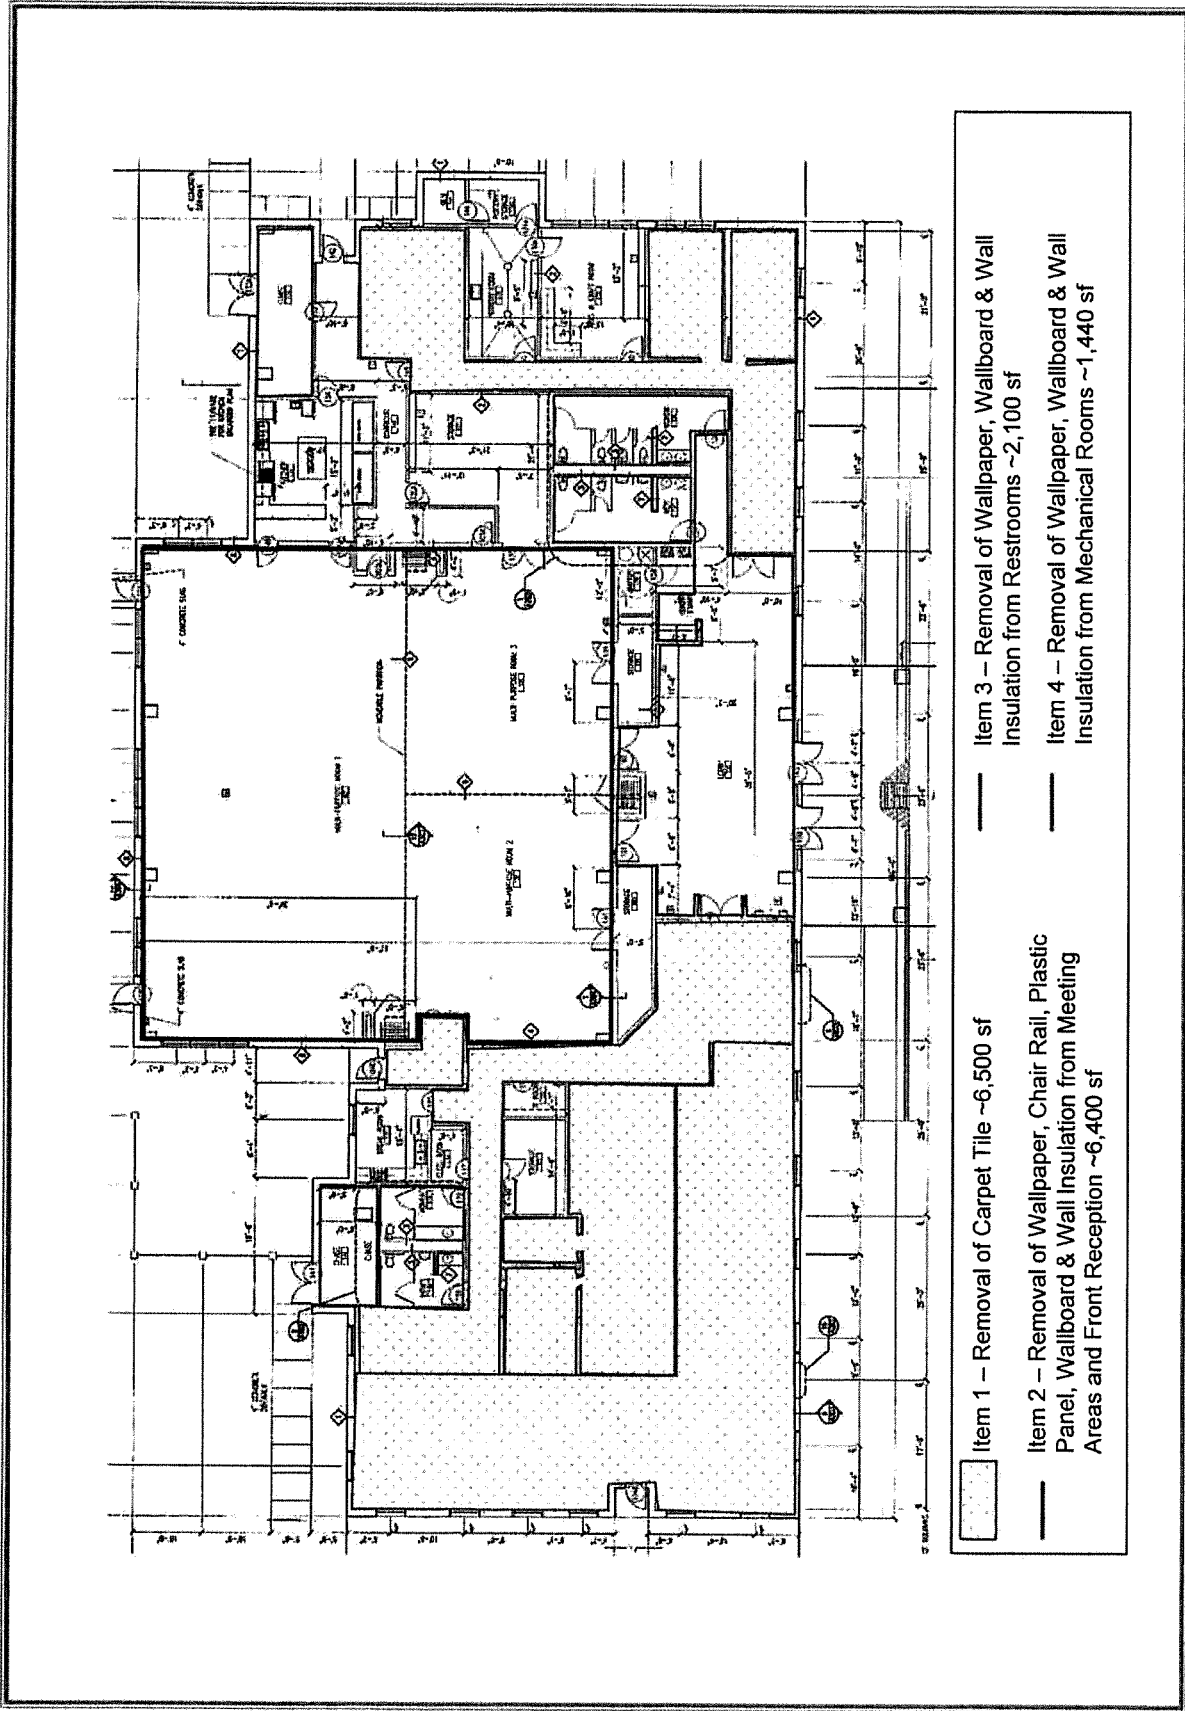
- Item 1 – Removal of Carpet Tile ~6,500 sf
- Item 2 – Removal of Wallpaper, Chair Rail, Plastic Panel, Wallboard & Wall Insulation from Meeting Areas and Front Reception ~6,400 sf
- Item 3 – Removal of Wallpaper, Wallboard & Wall Insulation from Restrooms ~2,100 sf
- Item 4 – Removal of Wallpaper, Wallboard & Wall Insulation from Mechanical Rooms ~1,440 sf

- All wall coverings (paper, chair rails, plastic panels), wallboard and associated insulation shall be removed in rooms/locations noted on the Remediation Scope of Work Drawings. All damaged materials and debris should be removed and disposed of. The area should be cleaned and sanitized including framing, exterior sheathing board, and flooring.
